INSPECTION REPORT

For the Property at:
101 MAIN STREET
MONTREAL, QC

Prepared for: JOHN SMITH
Inspection Date: Saturday, September 11, 2021
Prepared by: Matthew Kompan

HomeTech
1069 Rte 138
Elgin, QC J0S 2E0
514-777-7720

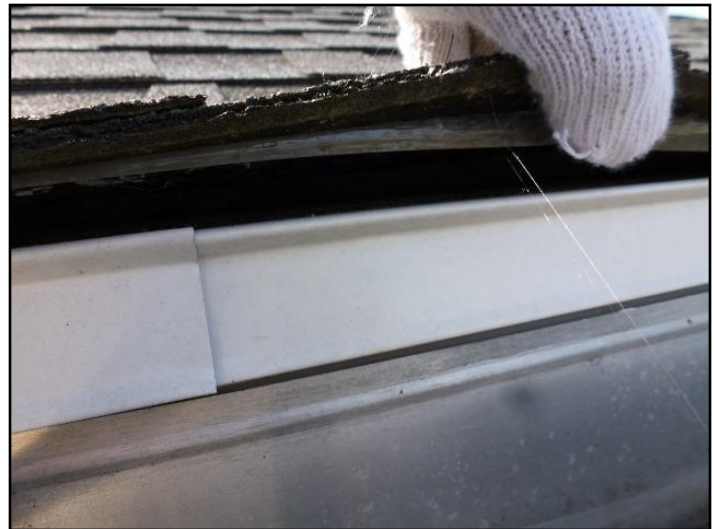
2. Flashing too far from roof surface

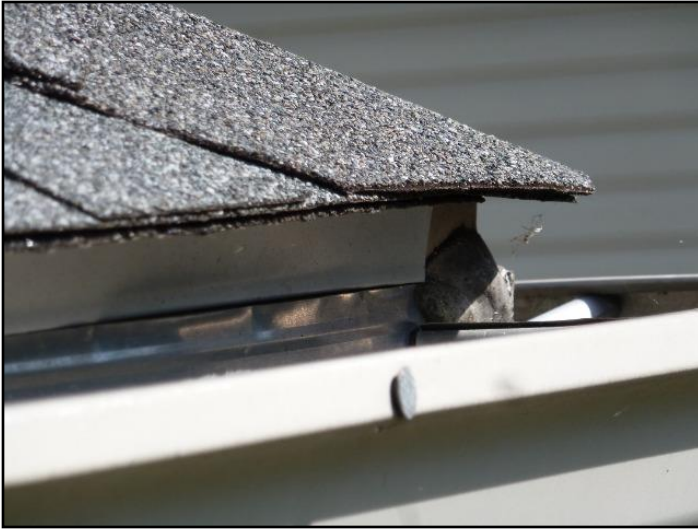
4. Missing drip edge

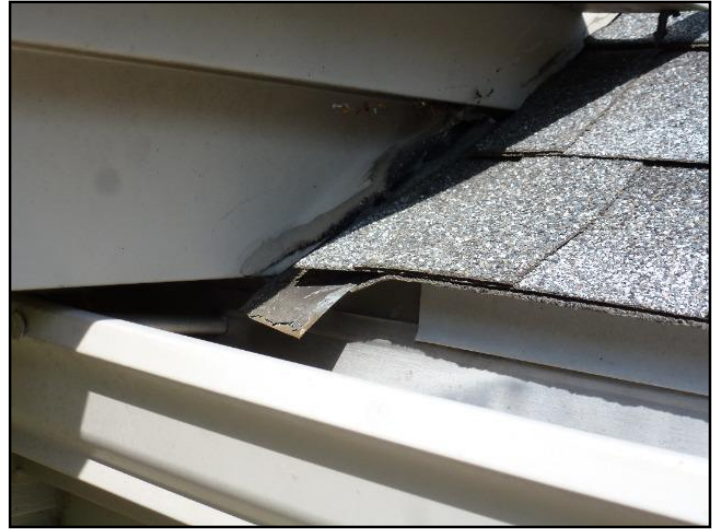
5. missing kick out

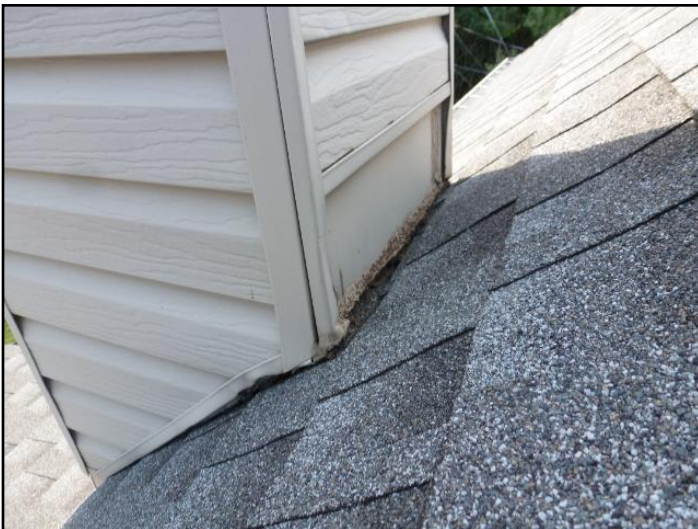
6. Improperly sealed

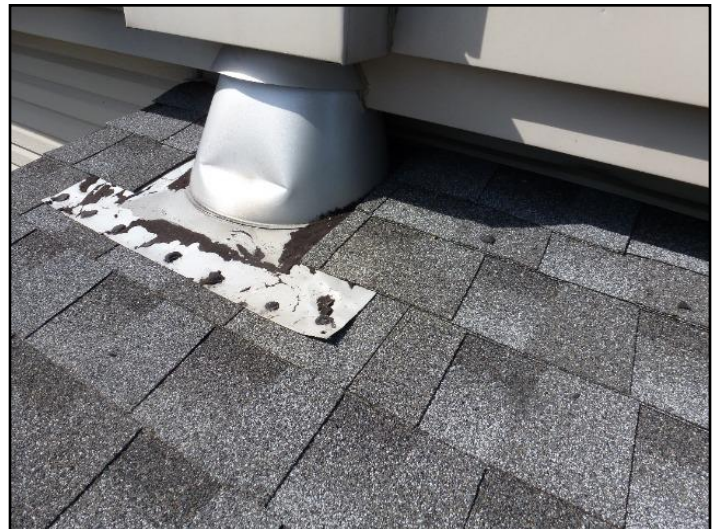
- 1. Condition:** • Several major deficiencies were noted on the roof including missing flashings, open seams around the chimney, improper installation of several flashings, missing drip edge, and in some areas the underlayment is missing. Step flashing is missing around the skylight and the skylight is installed too low to the roof surface the possibility of leak on the addition is extremely high.
- All of these issues may lead to water infiltration. Some water infiltration's are not noticeable or visible from inside the

7. improperly installed chimney flashing

Contact a qualified roofer to correct these deficiencies to reduce the risk of possible water infiltration. Perform periodic roof maintenance over the life of the roof to extend roof life and performance.

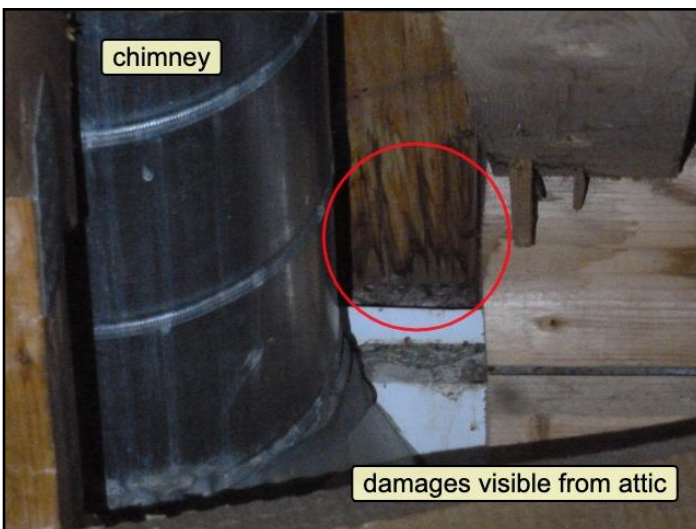
Water infiltration was noted in the attic around the chimney box this area due to its design is highly susceptible to leaks as already mentioned the area around the chimney needs to be sealed properly to avoid further damage to structure.

8. water damage

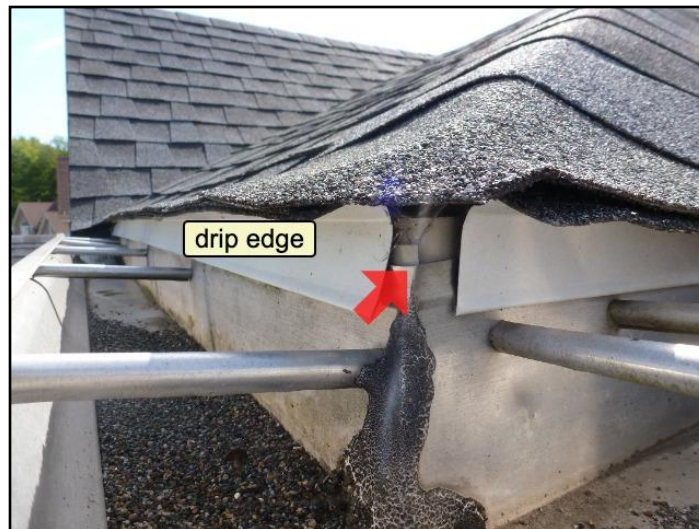
3. **Condition:** • It was observed that the drip edge is not continuous and improperly attached to the roof surface.

10. missing drip edge

Therefore it is highly possible that water could infiltrate in these areas. Contact a roofer to verify the continuity of the drip edge especially where terminating over rain gutters.

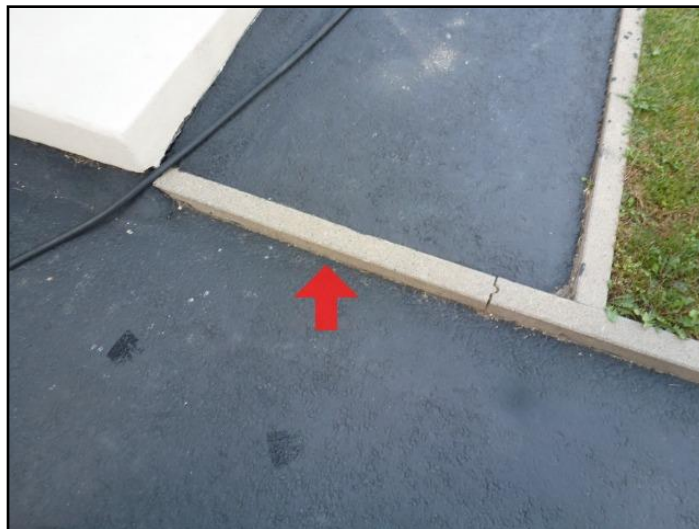
4. Condition: • Decorative stone between the driveway and the sidewalk to the front of the house and into the backyard is about 2 inches higher than the driveway or the sidewalk thus creating a trip hazard. It is recommended that the two surfaces are level.

11. trip hazard

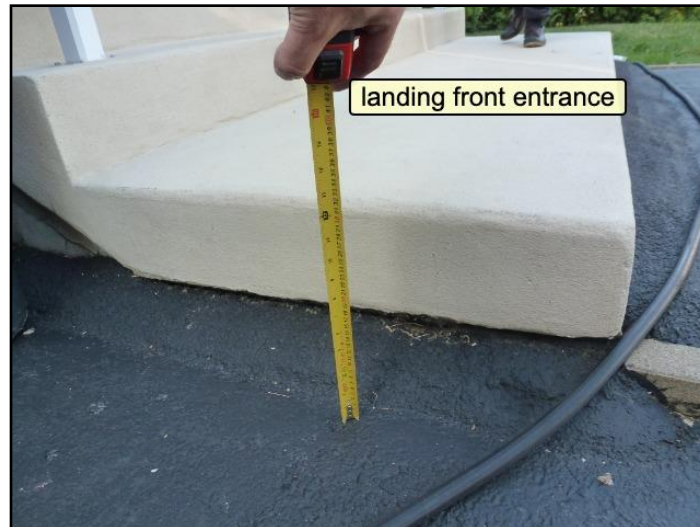
5. Condition: • The step to the bottom landing at the front entrance is of uneven height in some area exceeds 10 inches. The possibility of fall or tripping is very high.

12. trip hazard

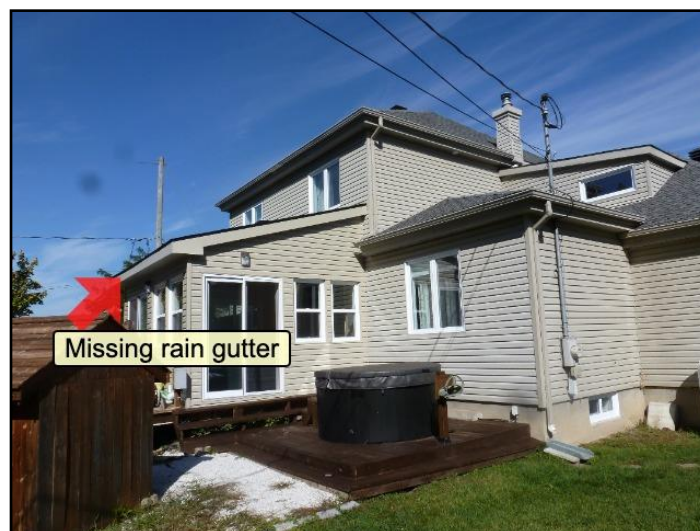
6. Condition: • The rear addition is under current construction. The rain gutter has not yet been installed. It is essential that one be installed with a downspout terminating at least 6 feet away from the home and in a way that the water would be directed away from the foundation. .

13. Missing rain gutter

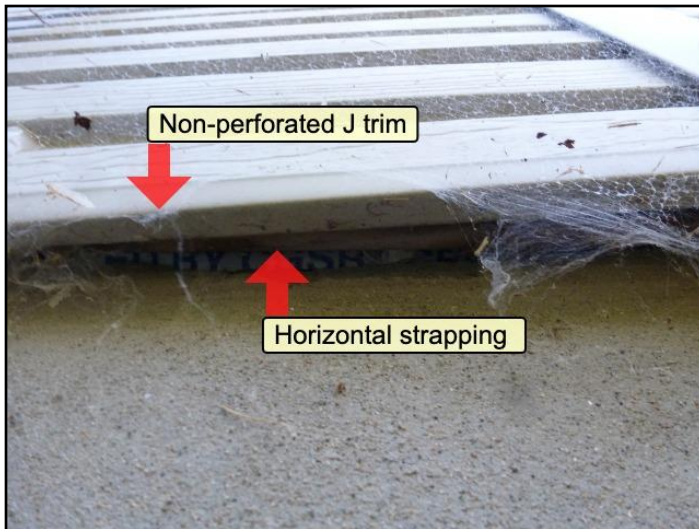
9. Condition: • The siding on the home was improperly installed. At the base where the siding starts, a horizontal strapping was installed. This retains water and condensation which runs down the air guard behind the siding. The water that sits on top of the strapping may deteriorate it and the structure of the home.

At the base of the siding a non-perforated J trim was installed. This will also retain water and channel the water into the corners or extremities on the J trim. Drilling small holes into the J trim at the base of the walls will improve the situation. The second picture and third picture show where the siding is detached over the garage roof and on the right side wall. Properly reattaching the siding is essential to prevent water infiltration and further damage to the siding.

18. Improperly install siding

Remove siding on the perimeter of the house just above the foundation inspect and correct the situation.

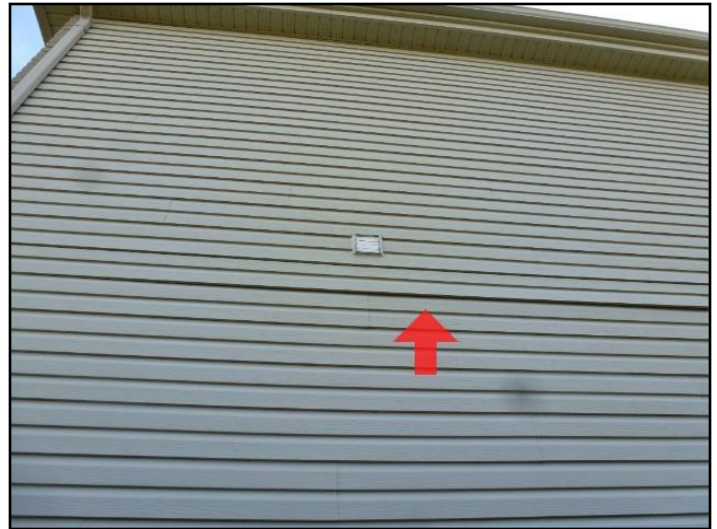
19. Detached siding

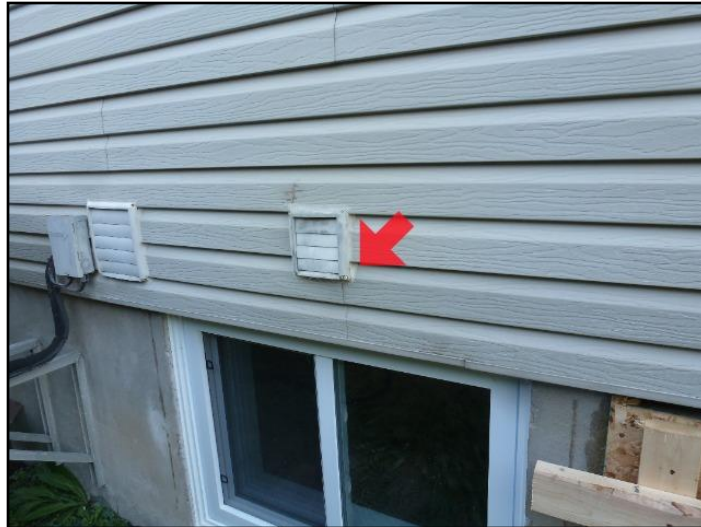
10. Condition: • Caulking around the vents on the exterior wall is deteriorated and in need of replacement. It would be highly recommended to replace the old plastic vents with new steel units it will provide a better seal and less exterior air intrusion.

21. Deteriorated caulking

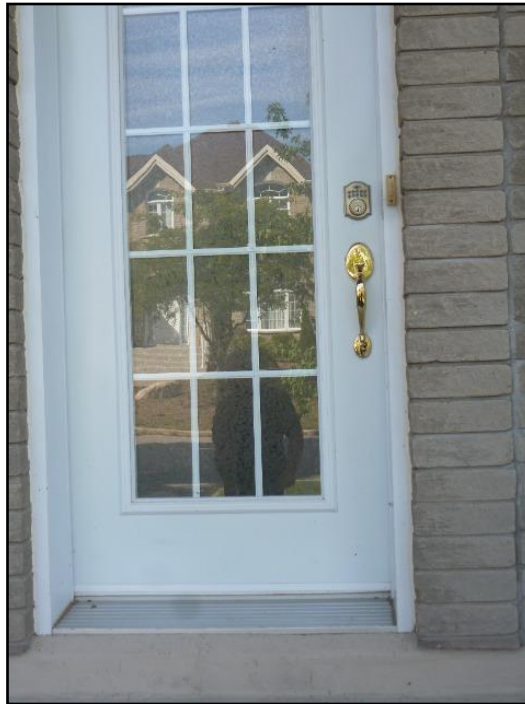
Caulking at the bottom of the front door is deteriorated and needs to be replaced.

22. Paint and Caulking - deteriorated / missing

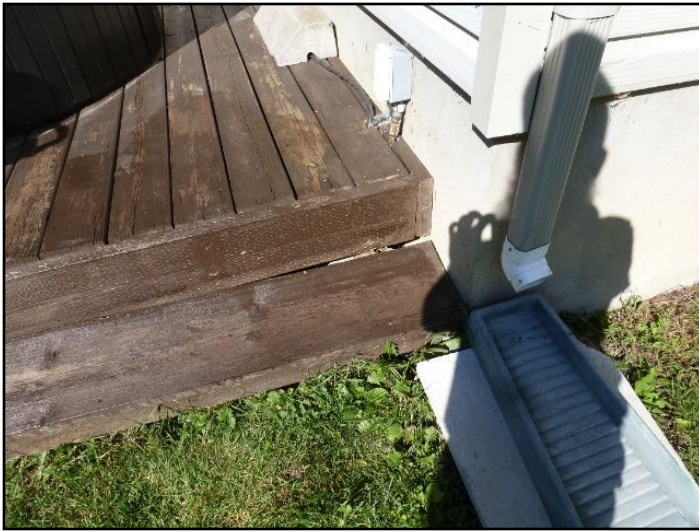
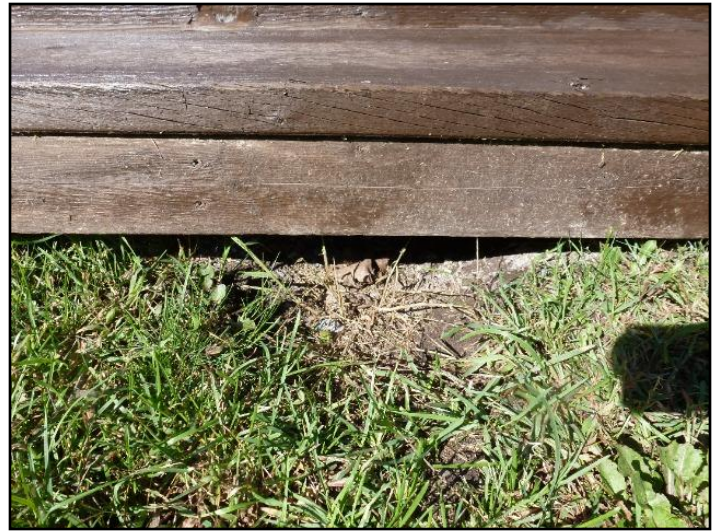
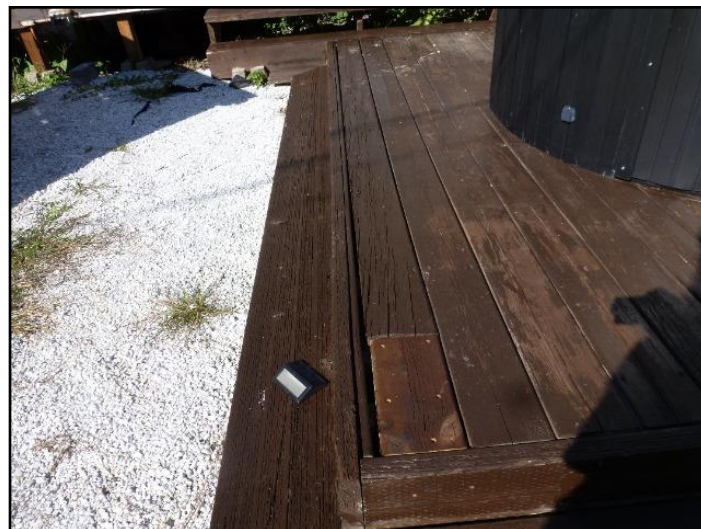
Rear lower deck where the hot tub is located is in very poor condition. Portions are rotten, broken steps are present, and the stairs going to the house are improperly secured and missing a railing at the rear extremity. Contact a certified general contractor for corrections.

Signs of rodents under the lower deck were also observed. Monitor the situation and if they're still present or return contact an exterminator.

23. Rot

24. Rot

25. Rot

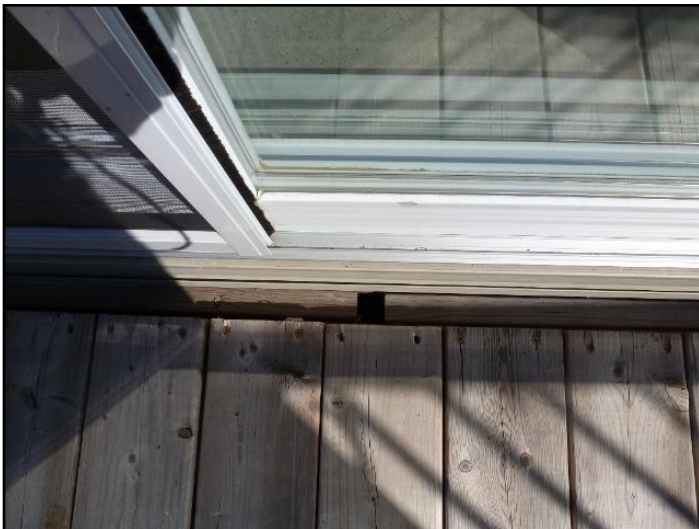
A deck needs to be continuously attached with a ledger boards to the building; there was no ledger board observed on three sides of the rear deck.

28. Missing ledger board

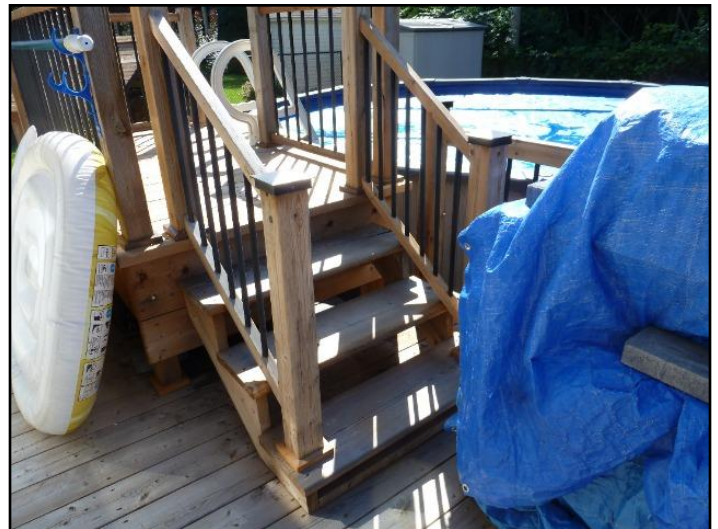
29. missing gate to pool

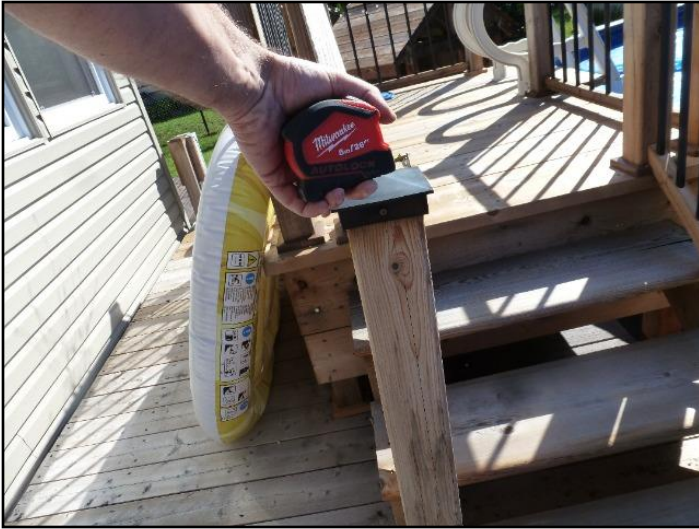
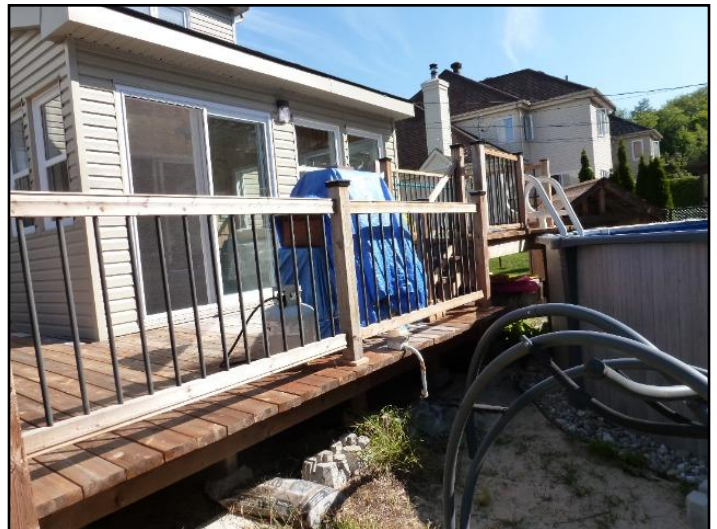
Railing on the perimeter is loose and improperly anchored into the deck structure.

30. Loose railing

33. Loose railing.

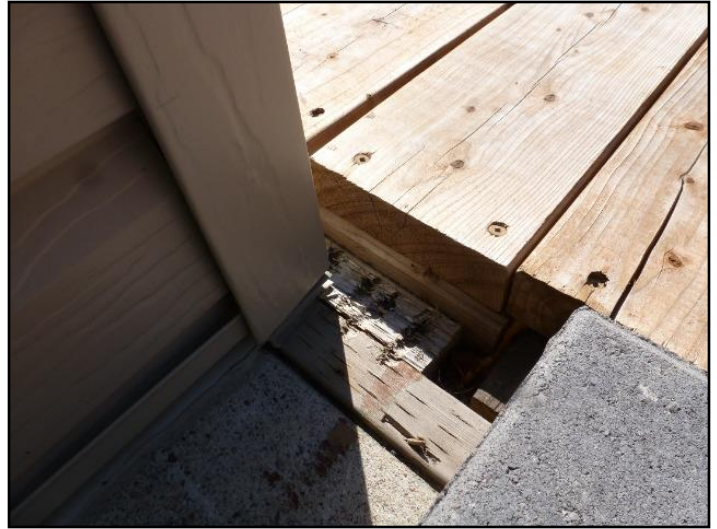
31. Trip hazard.

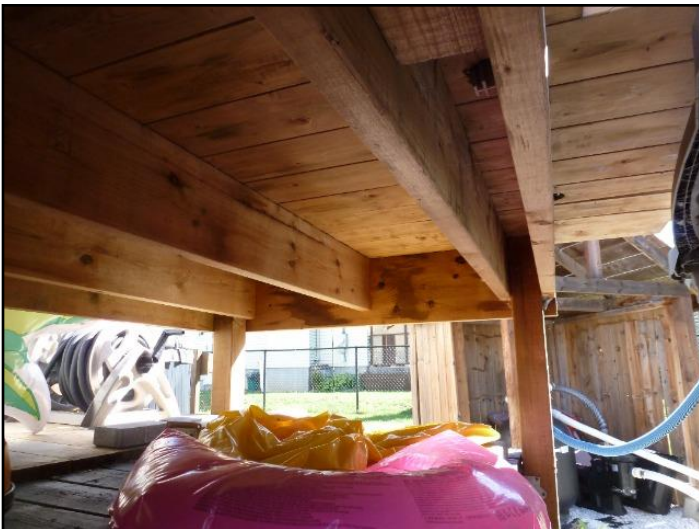
Upper deck to the pool is missing joist hangers and mechanical connection between posts and structure.

32. Missing joist hangers

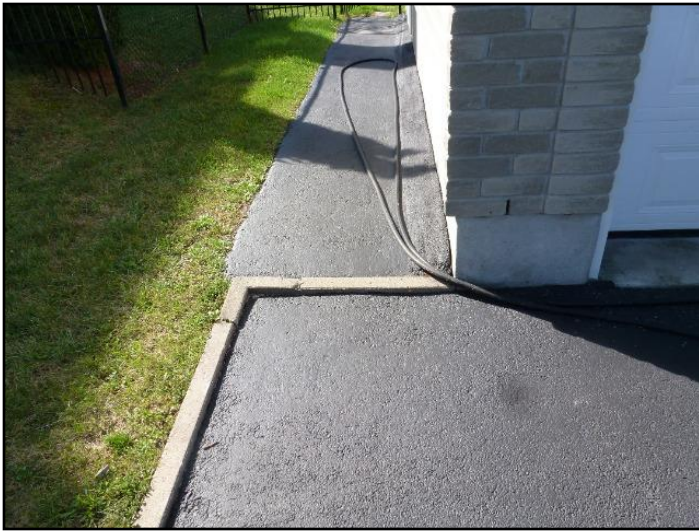
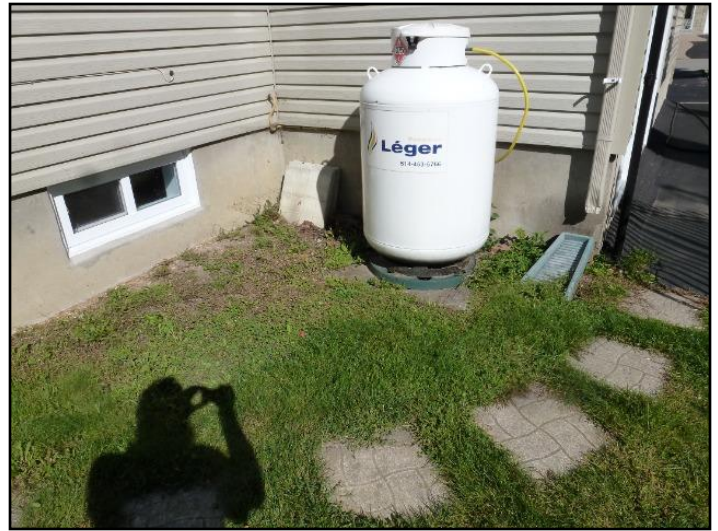
Negative slope towards the house was noted on the left side the rear and the right side of the home. This can allow for water to flow towards the foundation. It is important to re-slope the areas so that the rainwater is directed away from the property to reduce the risk of water infiltration and damages to the property.

35. Improper slope or drainage

36. Improper slope or drainage

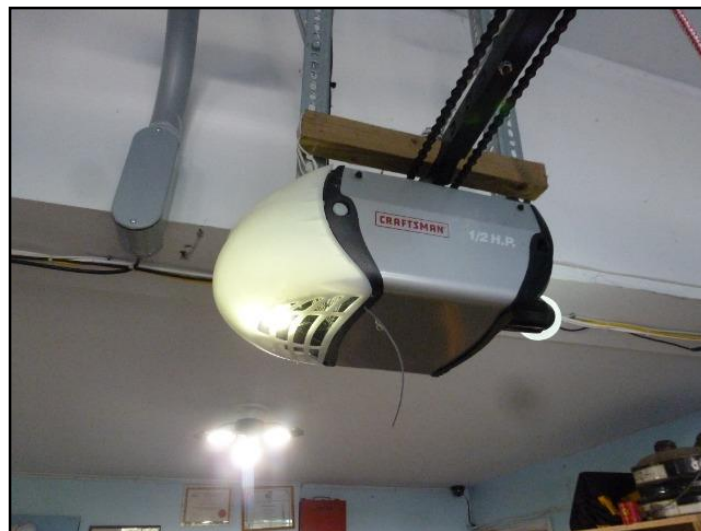
The garage door opener failed to auto reverse when pressure was applied. An adjustment is needed to the garage door opener to auto reverse should it come in contact with a person or an object placed under the opening while the door is closing. Contact the garage door specialist for adjustments.

37. Fails to auto reverse

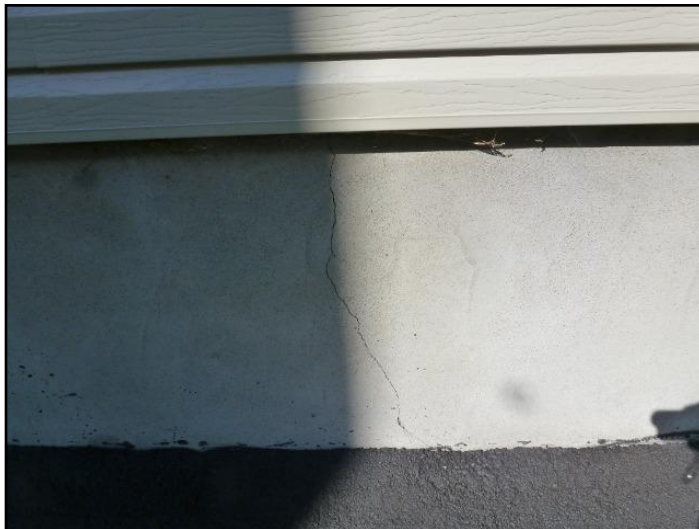
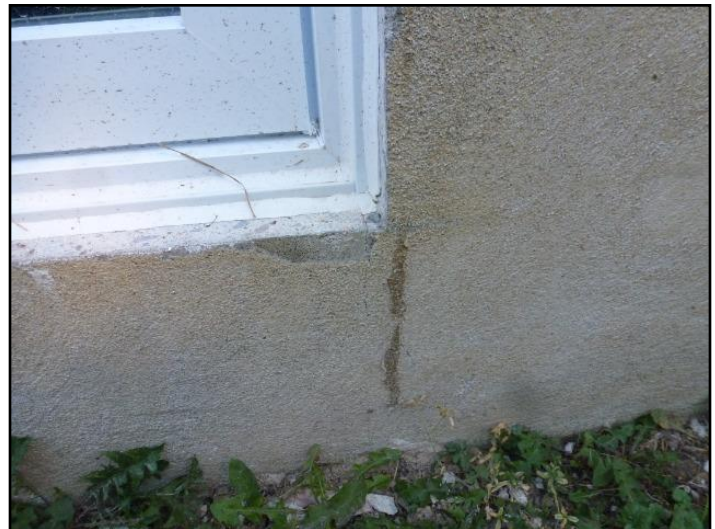
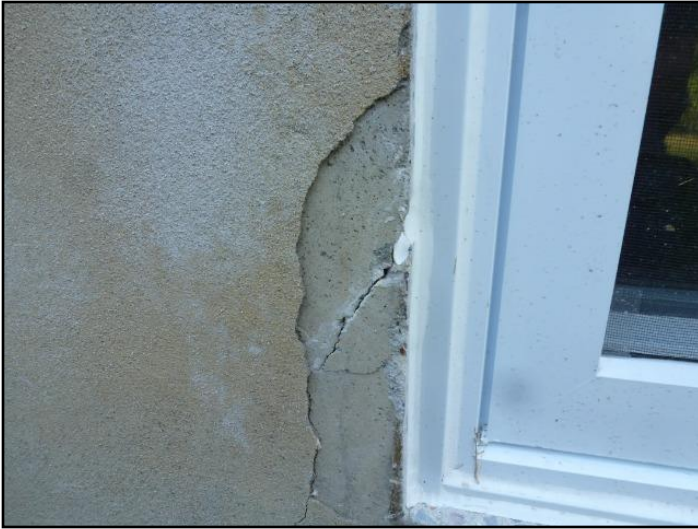
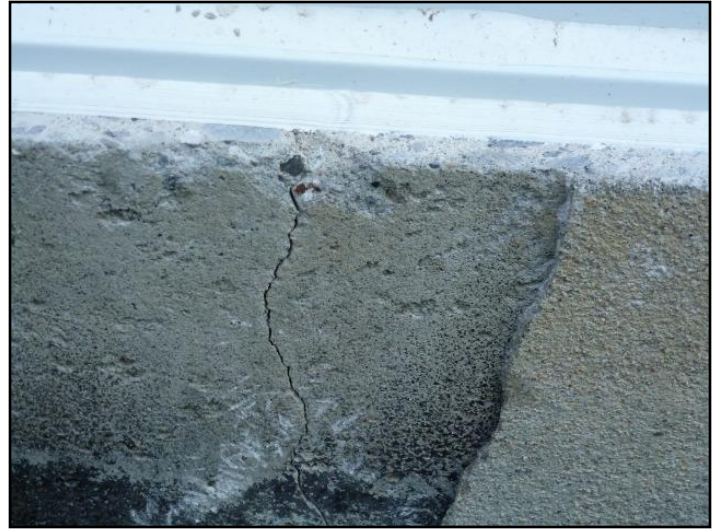
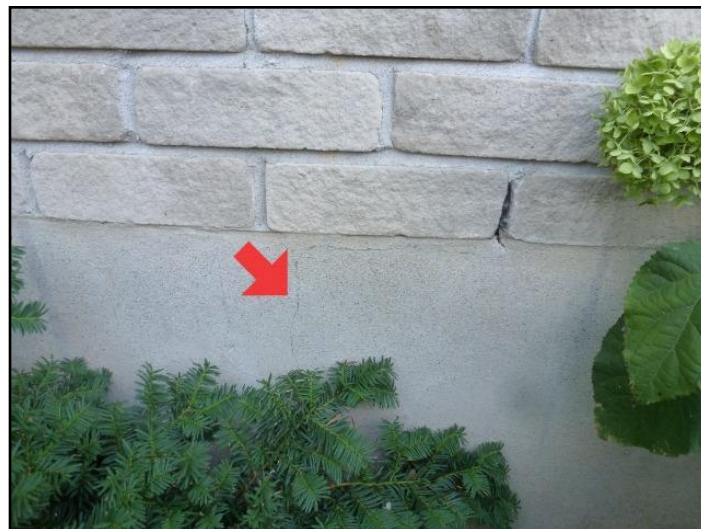
Five typical foundation cracks were noticed. It is essential that these would be sealed especially below grade to lower the risk of water infiltration and damage to the structure of the home.

38. Typical minor cracks

39. Typical minor cracks

40. Typical minor cracks

41. Typical minor cracks

42. Typical minor cracks

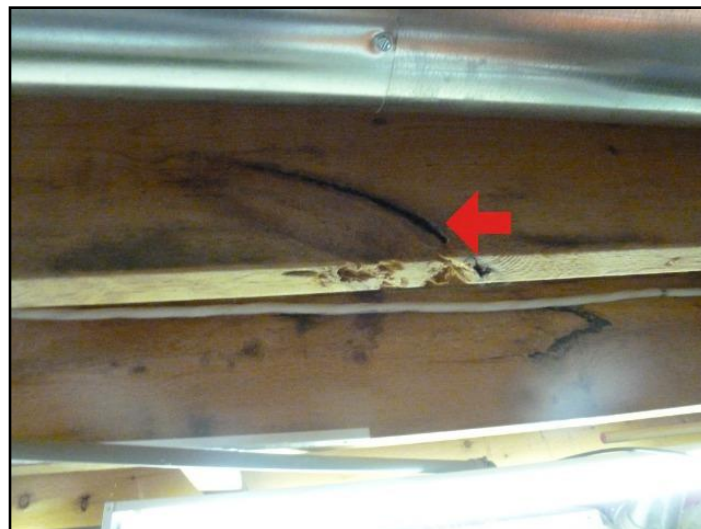
Split in one of the floor joists was noted it is recommended to reinforce it by adding additional lumber on either side. Contact a certified general contractor for proper correction.

43. Split or damaged

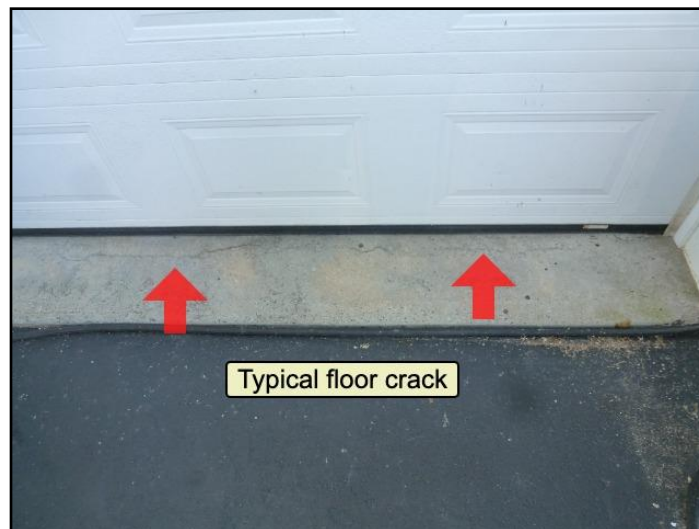
Typical floor cracks were noticed in the garage floor. The cracks that are on the exterior of the garage door should be sealed to avoid water infiltration and freezing in the winter.

44. Cracked

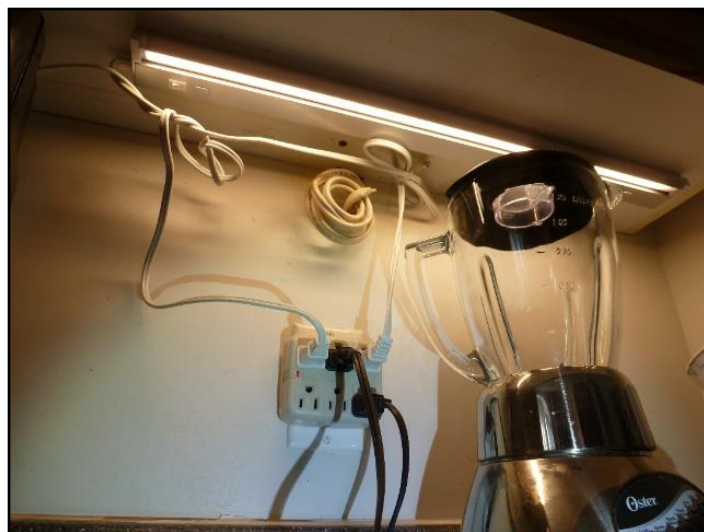
23. Condition: • Exposed live wires. Live wires not enclosed in electrical box were noted in several areas of the home: in the garage on the left wall, on the outside over the exterior door entrance to the basement, and under the kitchen cabinets.

52. exposed wires

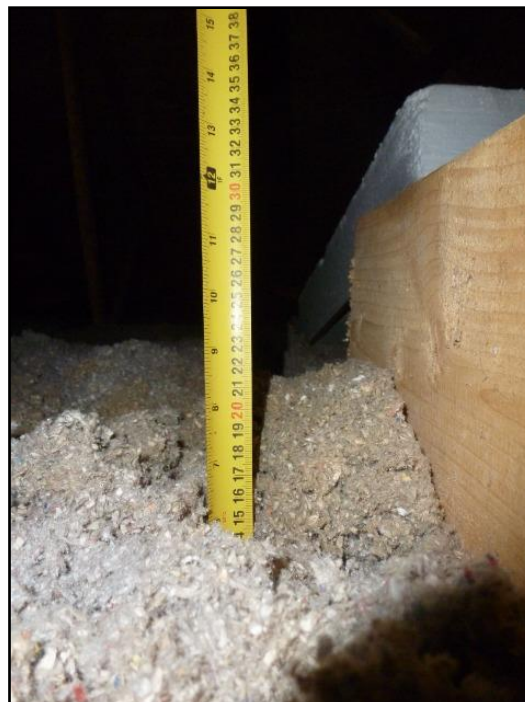
30. Condition: • 7 inches of cellulose insulation were observed in the attic providing approximately a R value of 25 it is recommended for the R-value in the attic to be 51 therefore more cellulose could be added to improve the efficiency of the home and reduce heat loss the possibility of ice damming and icicles on the roof.

64. Cellulose insulation

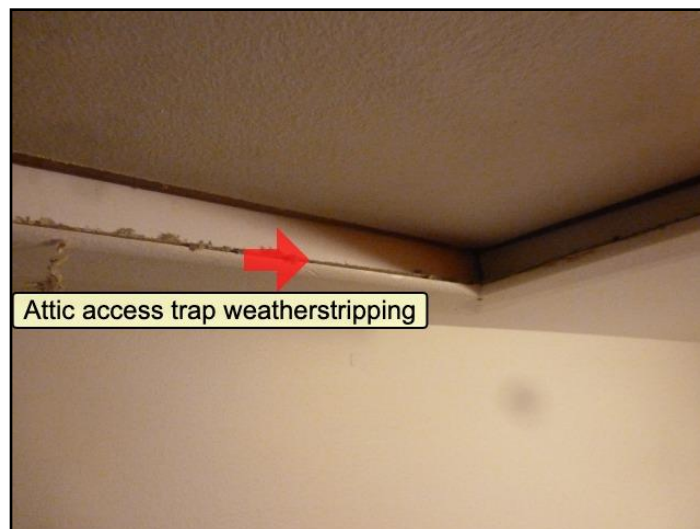
31. Condition: • The attic access trap located in the master bedroom closet has a damaged seal due to very frequent opening. Replace the seal to reduce heat loss.

65. Damaged seal

Contact a certified general contractor for corrections.

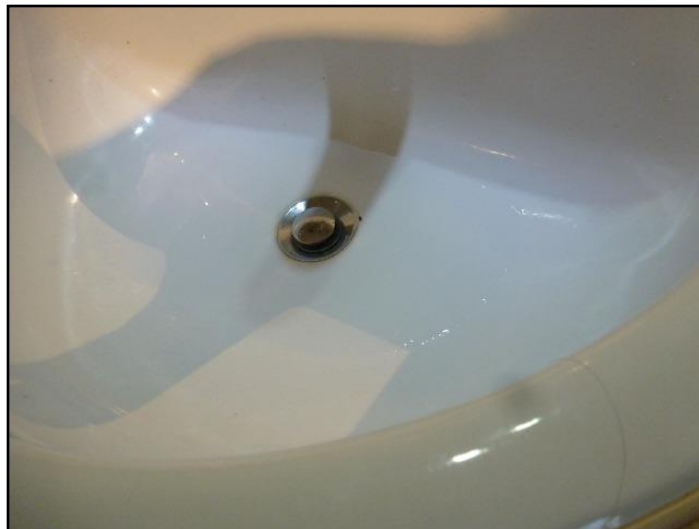
74. Clogged

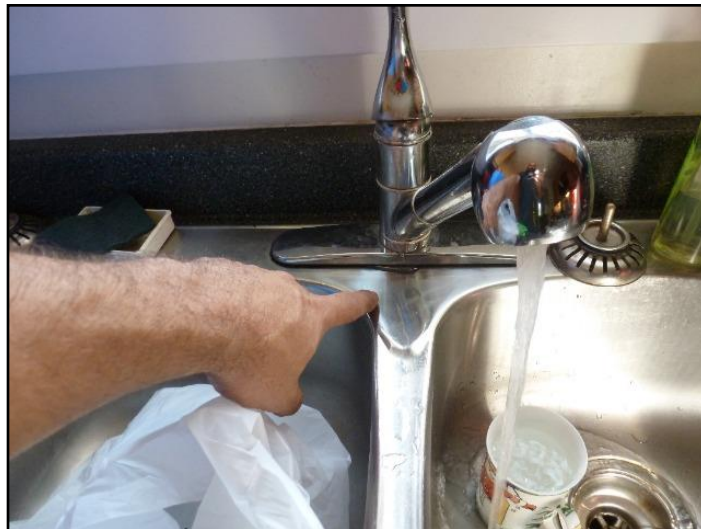
Kitchen faucet leaks around the base. Replace the kitchen faucet to avoid damage to countertop and cabinetry. Contact a certified plumber for corrections.

76. Drip, leak

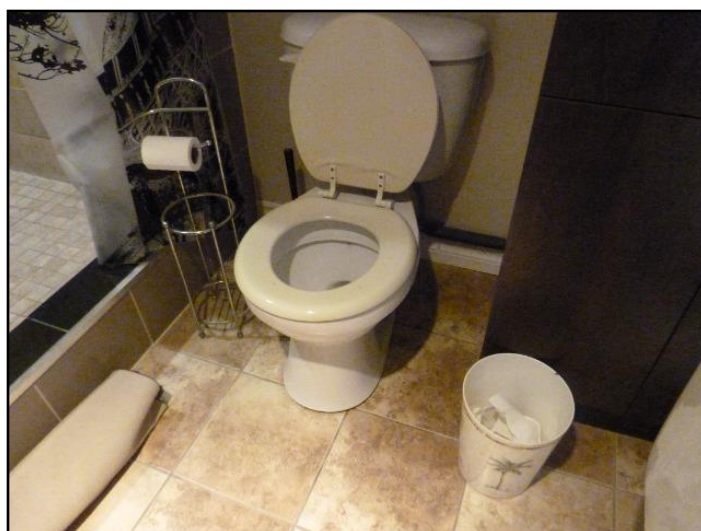
Basement toilet is loose it should be removed inspected for damages to the wood structure and subfloor around it and reinstalled with a proper seal.

77. Loose

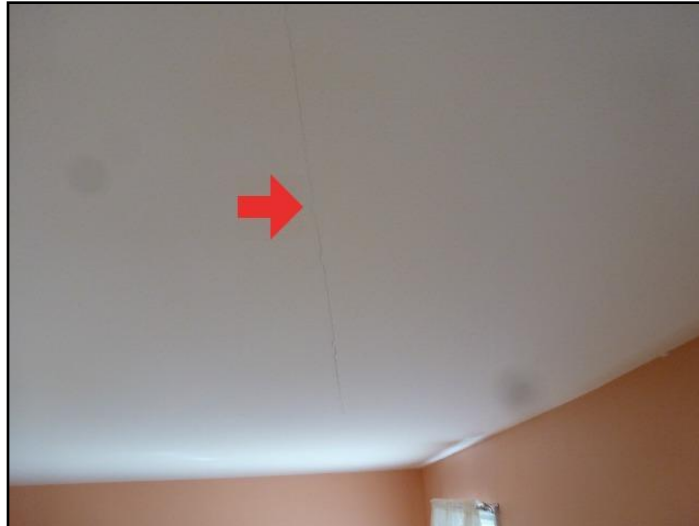
Minor cracks and flaws are noticed on the first floor ceiling repair and monitor these areas, should the cracks return after proper repairs it may indicate movement in the structure further evaluation will be required at that point.

78. Typical minor flaws

Contact a certified general contractor for corrections.

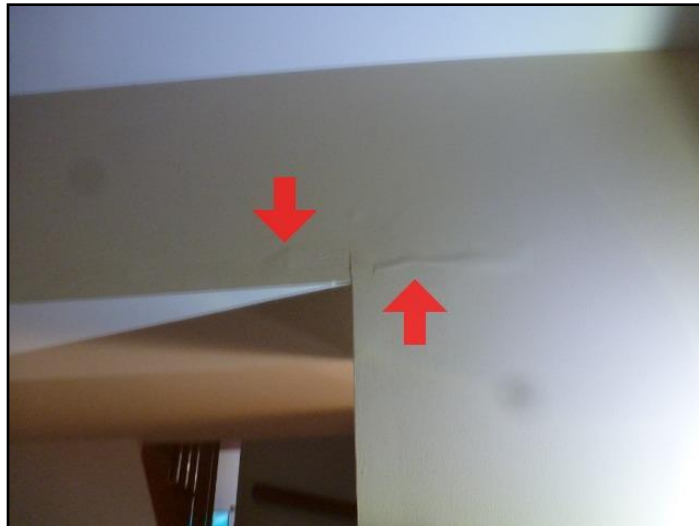
42. Condition: • Although common this is an area that needs to be monitored, as signs of compression or settlement in the structure were noted in the doorway from the living room to the dining room. Repair the area and monitor for further movement. Contact a certified general contractor for further evaluation and corrections.

79. structure under pressure

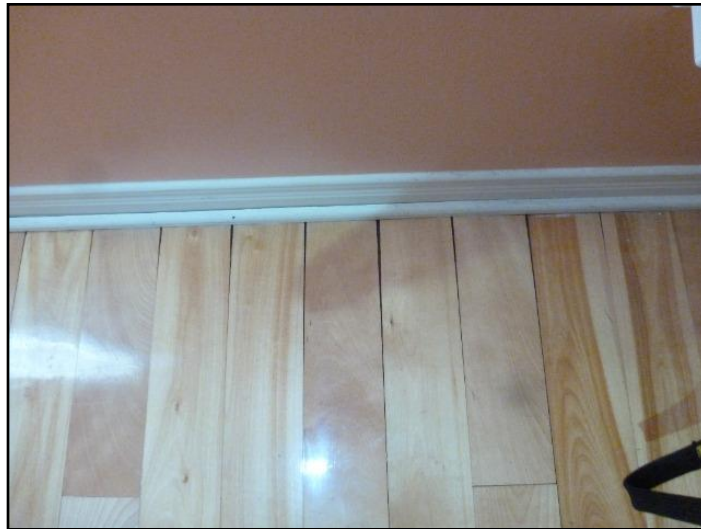
typical minors flaws were noticed on the main floor including a very small area that shows signs of previous water damage in the dining room to the left of the patio door.

80. Typical flaws

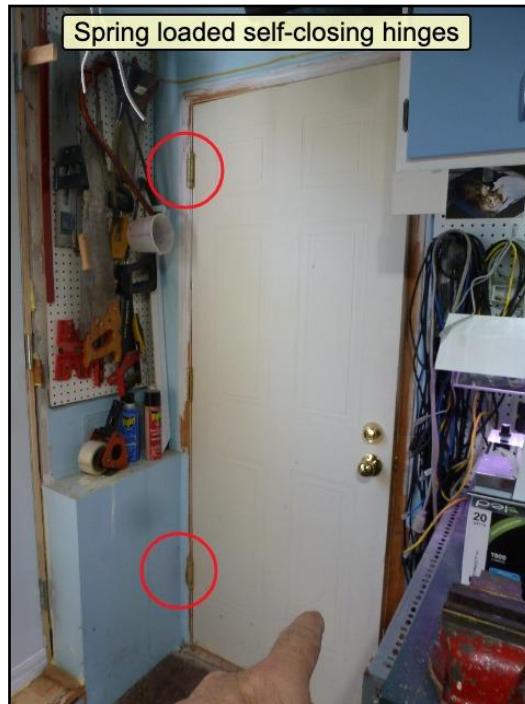
82. Fire door doesn't shut

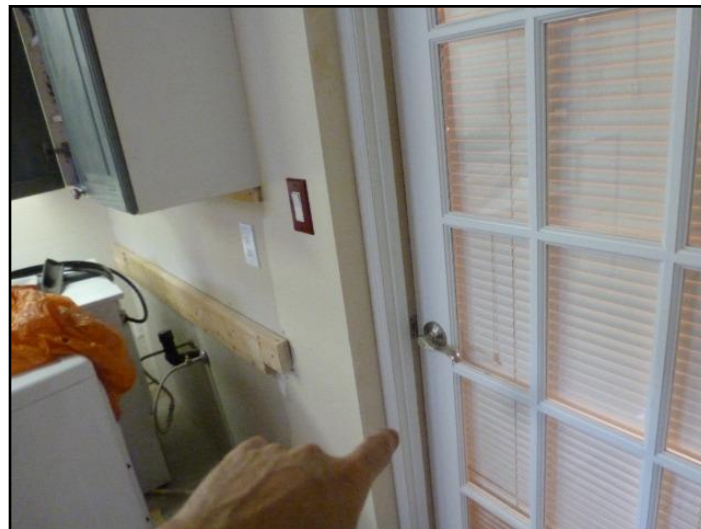
83. Stiff

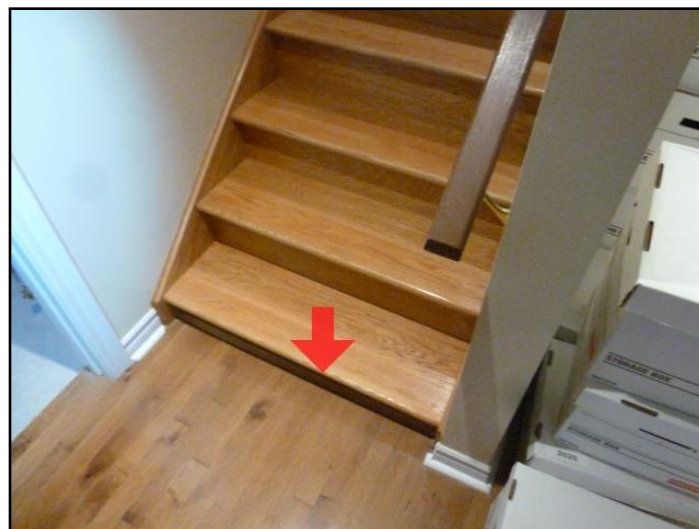
Bottom step into the basement from the main home is of much lower height than the rest. This may cause a tripping hazard. Contact a certified general contractor for corrections.

84. Rise or run not uniform

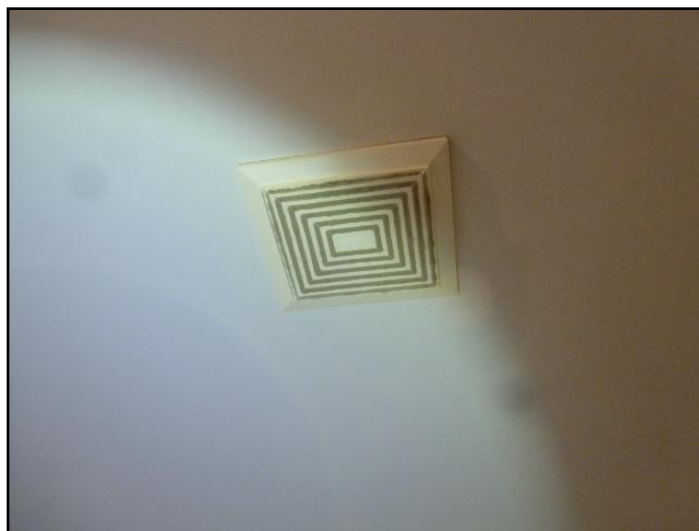
86. Inoperative
