INSPECTION REPORT

For the Property at:
101 MAIN STREET
MONTREAL, QC

Prepared for: JOHN SMITH
Inspection Date: Saturday, September 11, 2021
Prepared by: Matthew Kompan

HomeTech
1069 Rte 138
Elgin, QC J0S 2E0
514-777-7720

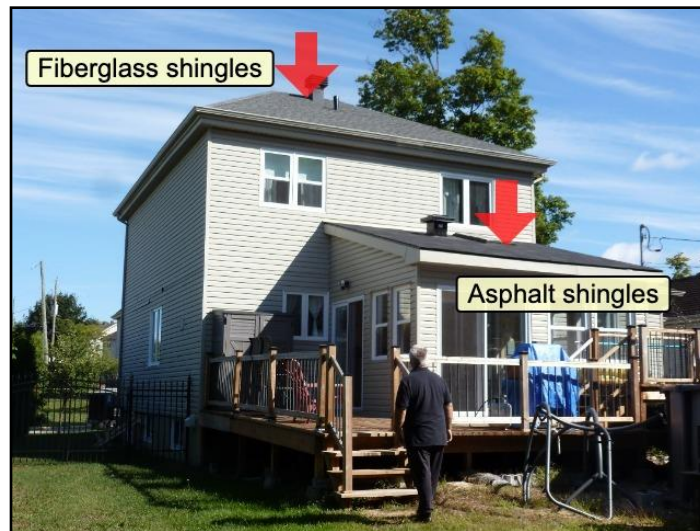
1. shingles

Fiberglass shingles are installed on the main house and asphalt shingles are on the rear addition's roof.

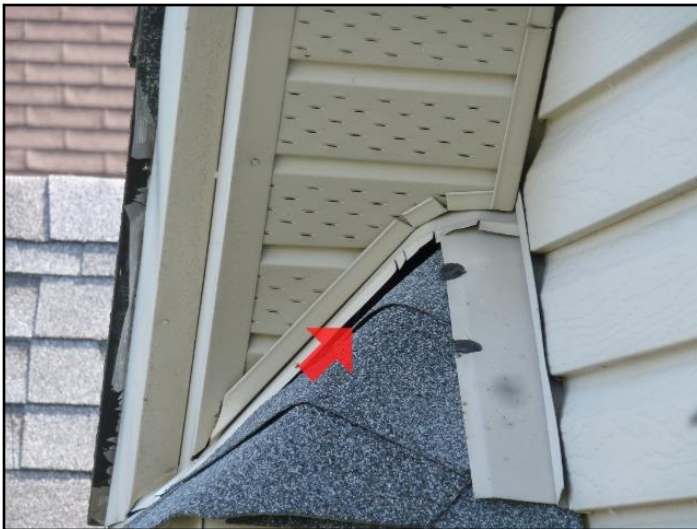
2. Flashing too far from roof surface

- 1. Condition:** • Several major deficiencies were noted on the roof including missing flashings, open seams around the chimney, improper installation of several flashings, missing drip edge, and in some areas the underlayment is missing. Step flashing is missing around the skylight and the skylight is installed too low to the roof surface the possibility of leak on the addition is extremely high.
- All of these issues may lead to water infiltration. Some water infiltration's are not noticeable or visible from inside the

home at first, however water infiltration can affect many different factors and components of the house before they become noticeable inside.

Contact a qualified roofer to correct these deficiencies to reduce the risk of possible water infiltration. Perform periodic roof maintenance over the life of the roof to extend roof life and performance.

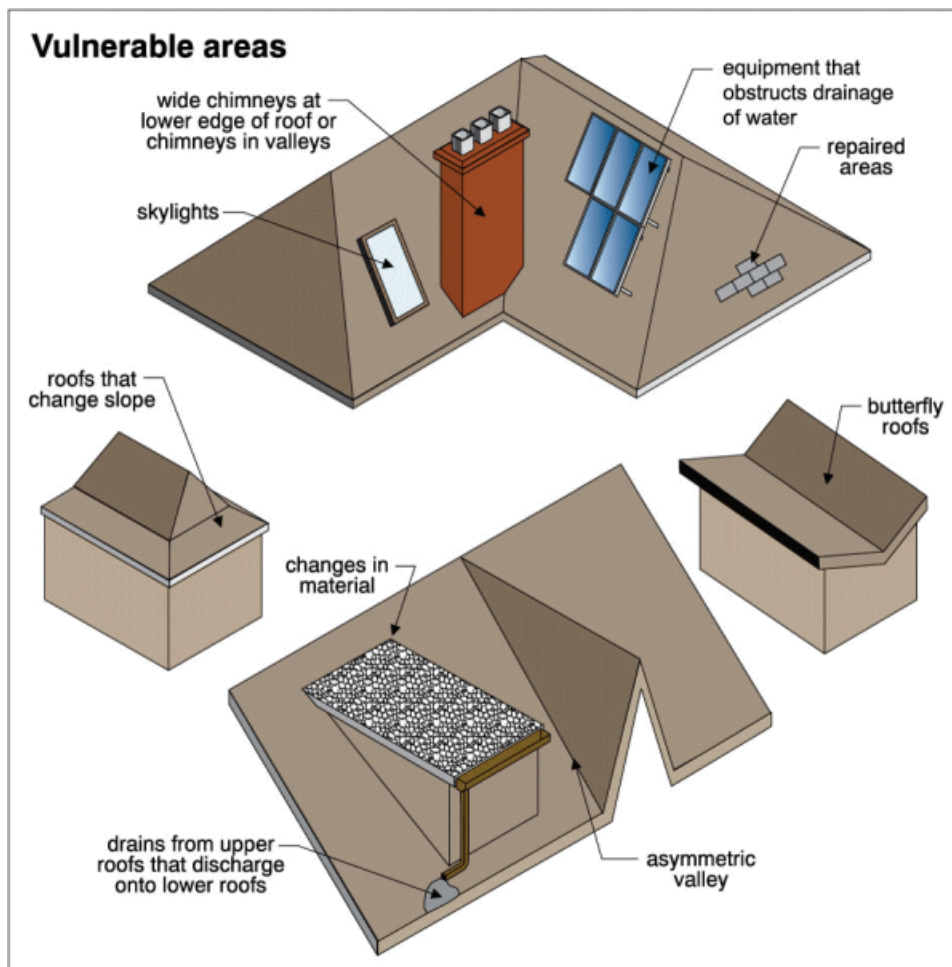
8. water damage

Water infiltration was noted in the attic around the chimney box this area due to its design is highly susceptible to leaks as already mentioned the area around the chimney needs to be sealed properly to avoid further damage to structure.

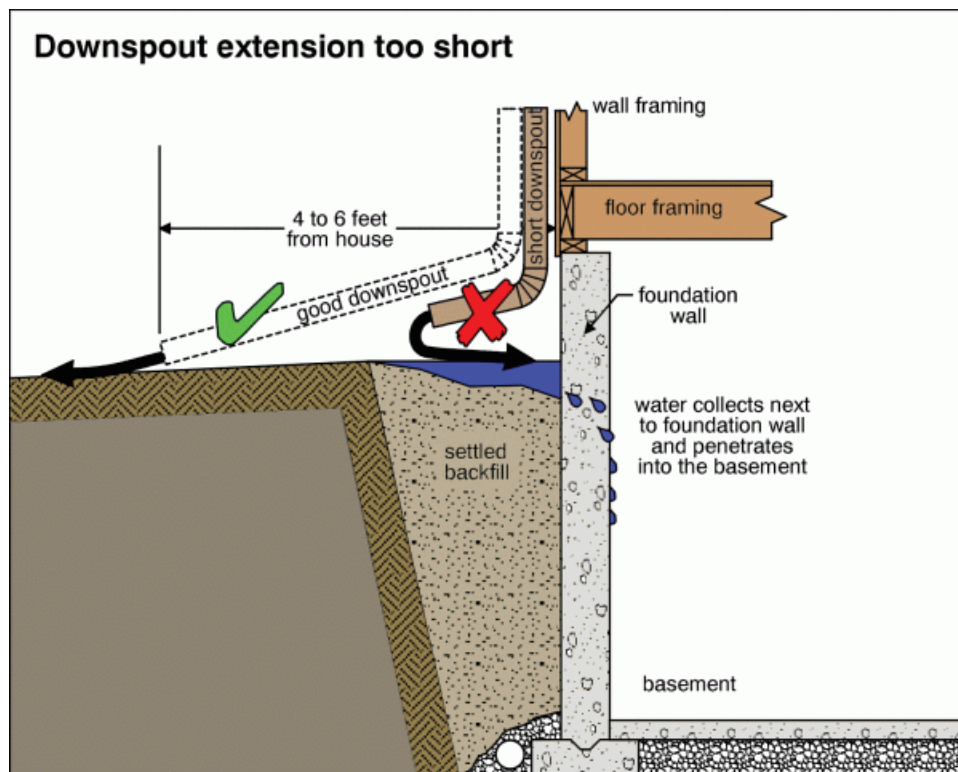
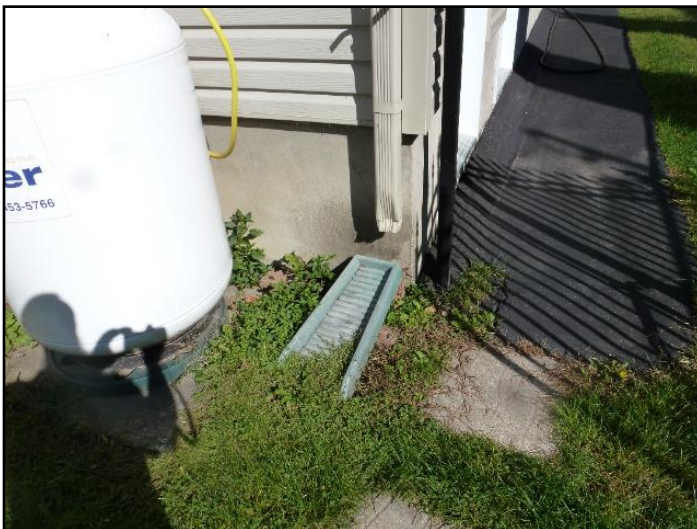
14. Discharge too close to building

Three of the downspouts' discharge are too close to the building. It is recommended that the water discharge is at least 6 feet long to allow water drainage away from the foundations. Also keep in mind when installing a downspout extension not to create a trip hazard if near a sidewalk or stairs.

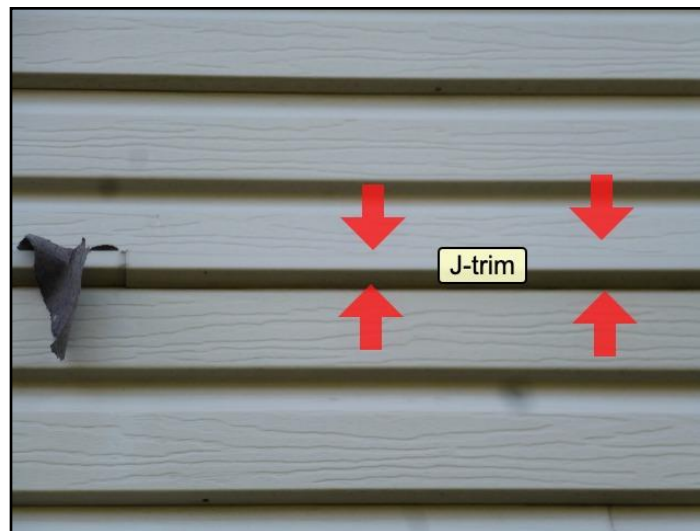
17. j-trim mid wall

8. Condition: • Siding - incomplete / missing

it is unclear why this J-trim is installed mid wall. Contact a certified general contractor for corrections.

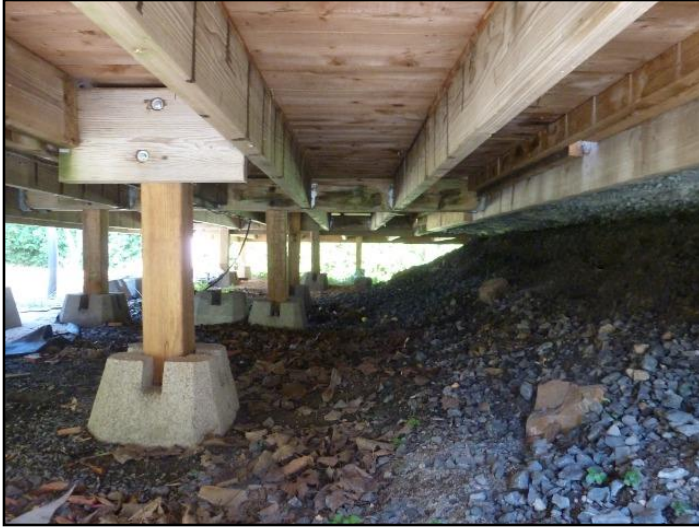
26. Poorly built

Many issues were observed with the rear patio. Corrections are necessary to the structure, railing, and decking boards. Some of the 4 x 4 supports are not vertical, but are angled. They need to be readjusted and reattached properly to the structure.

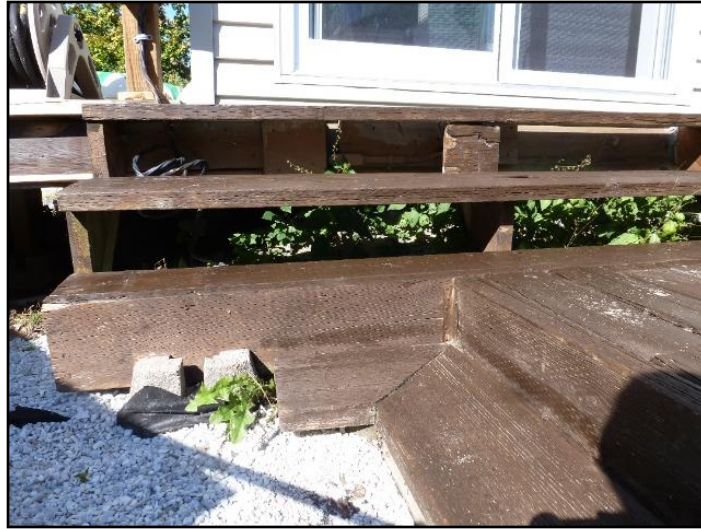
34. Wood/soil contact

It's recommended that all wood structures would be at least 6 inches from the ground. When Wood becomes in contact with the ground and retains moisture and deteriorates quickly. When repairing or reconstructing the rear deck insured that it's done in a way that all wood components are a minimum of 6 inches from the ground.

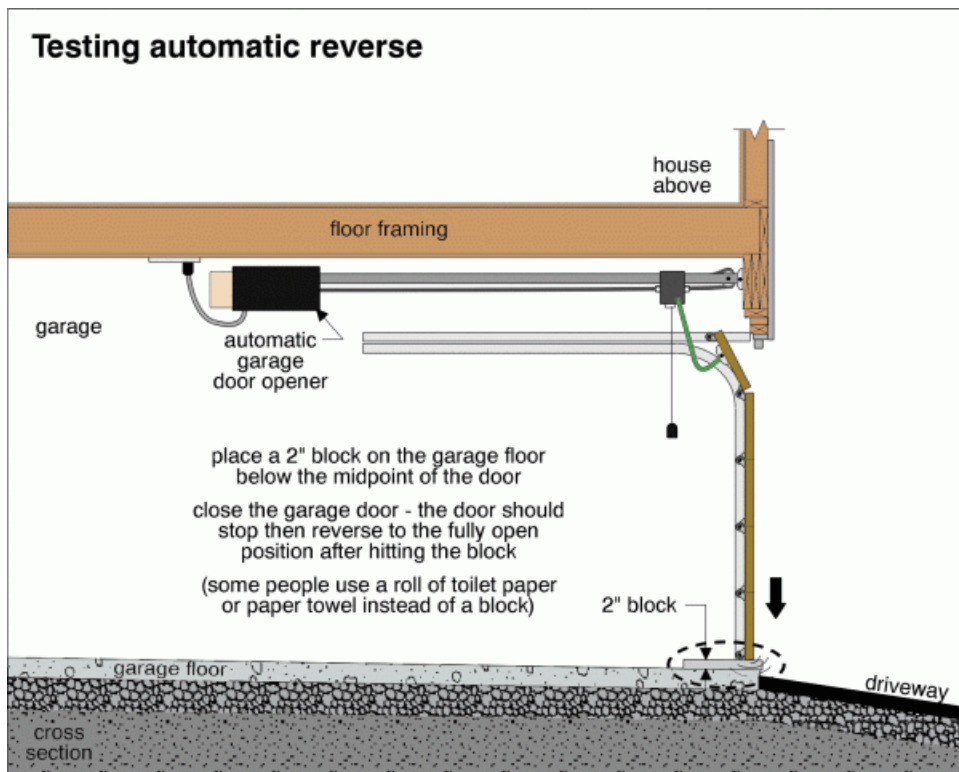
37. Fails to auto reverse

The garage door opener failed to auto reverse when pressure was applied. An adjustment is needed to the garage door opener to auto reverse should it come in contact with a person or an object placed under the opening while the door is closing. Contact the garage door specialist for adjustments.

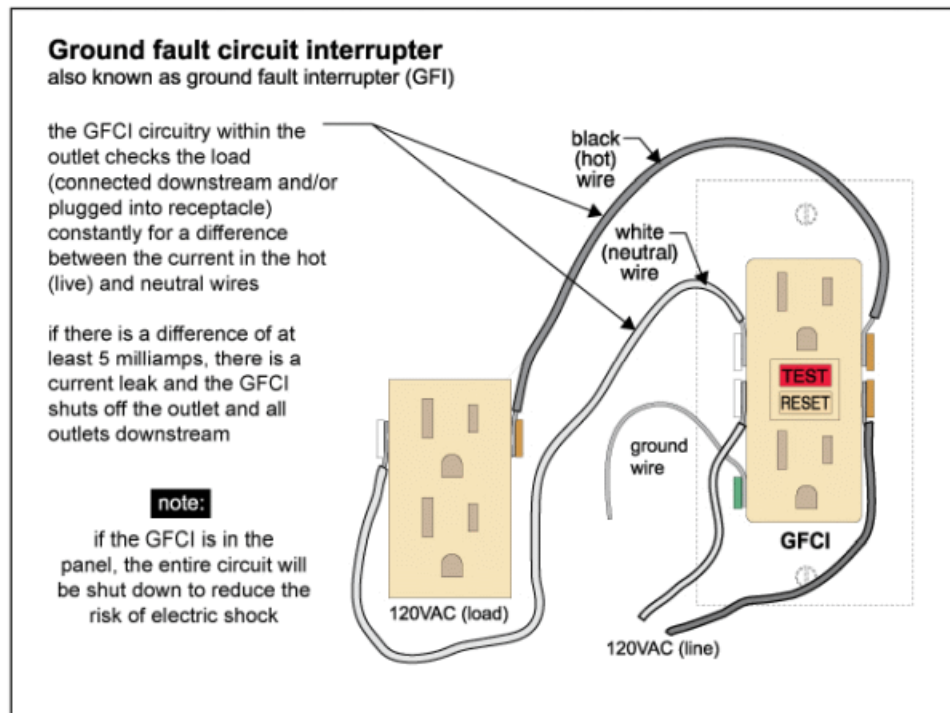
54. No GFCI/GFI (Ground Fault Circuit...

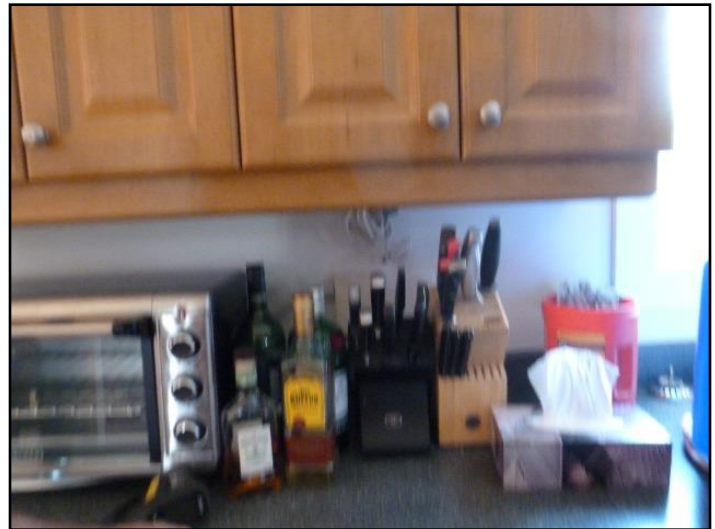
55. No GFCI/GFI (Ground Fault Circuit...

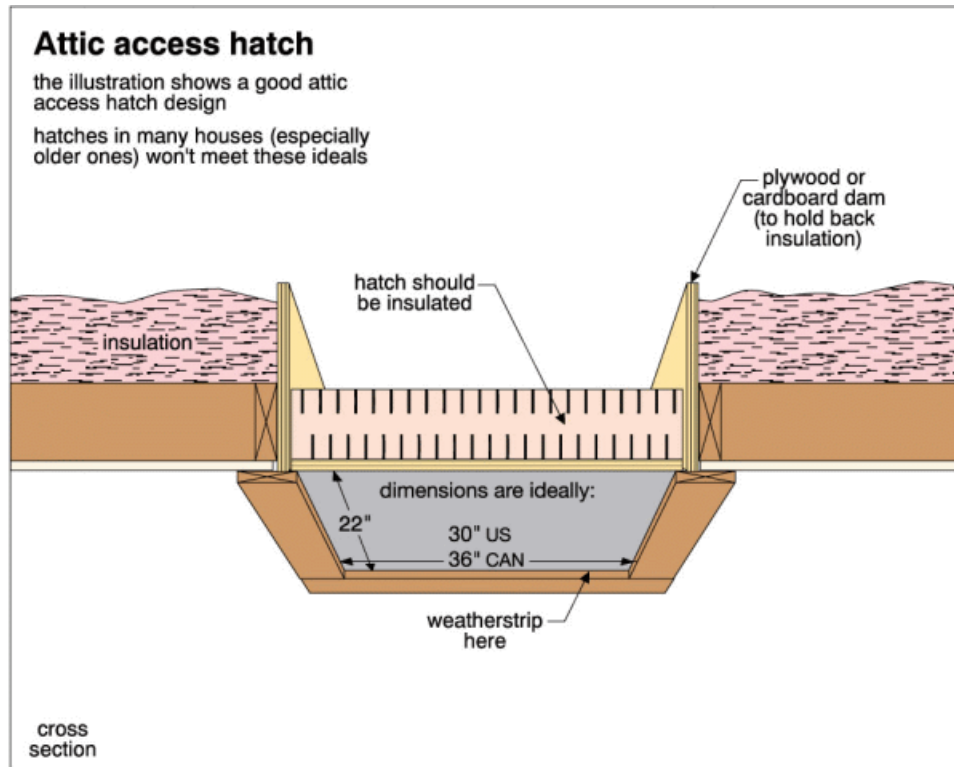
31. Condition: • The attic access trap located in the master bedroom closet has a damaged seal due to very frequent opening. Replace the seal to reduce heat loss.

65. Damaged seal

Contact a certified general contractor for corrections.

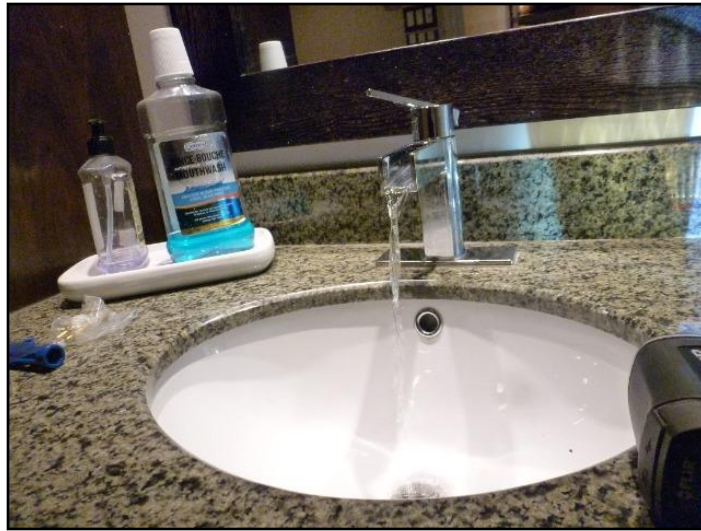
32. Condition: • [Poor pressure or flow](#)

Low water pressure was observed in the basement and in the kitchen. Contact a certified plumber to remedy the problem if needed.

72. Poor pressure or flow

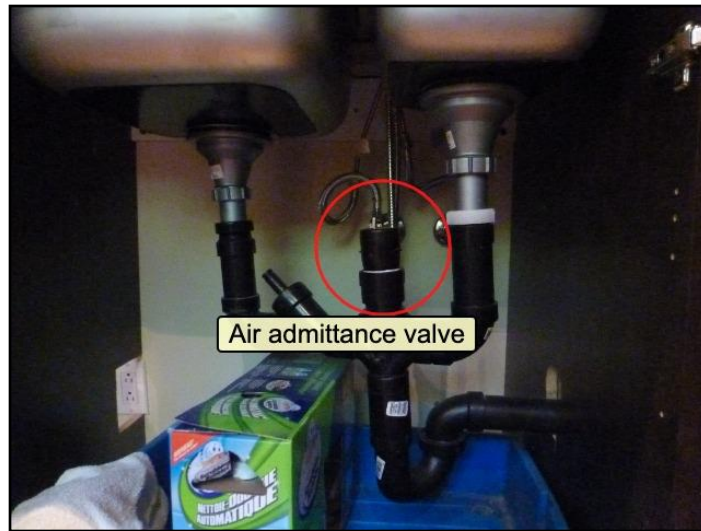
33. Condition: • Air admittance valve located under the sink in the basement kitchen is installed too low. These valves need to be installed as high as possible under the cabinet.

73. to low

Reinstalled the valve at a higher level under the cabinet. Contact a certified plumber for corrections.

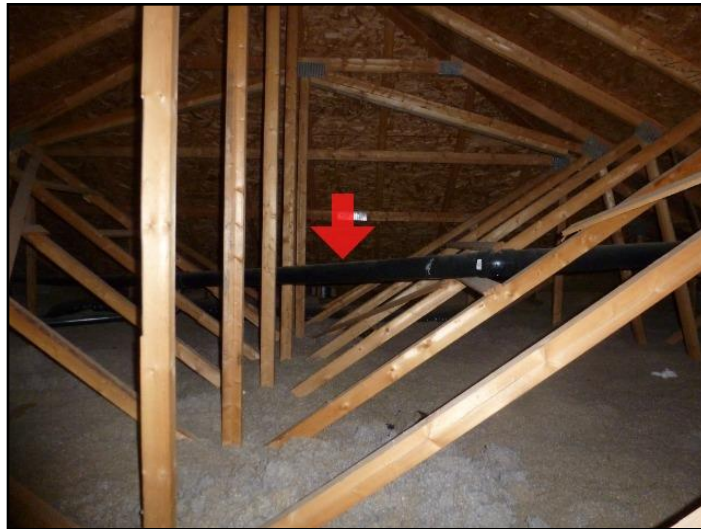
35. Condition: • Drain vent pipe is improperly supported in the attic. Add supports to ensure proper drainage and to prevent the pipe from disconnecting, thus causing water infiltration and sewage smell in the home.

Implication(s): Water infiltration and sewage gases entering the home

75. Sufficient support

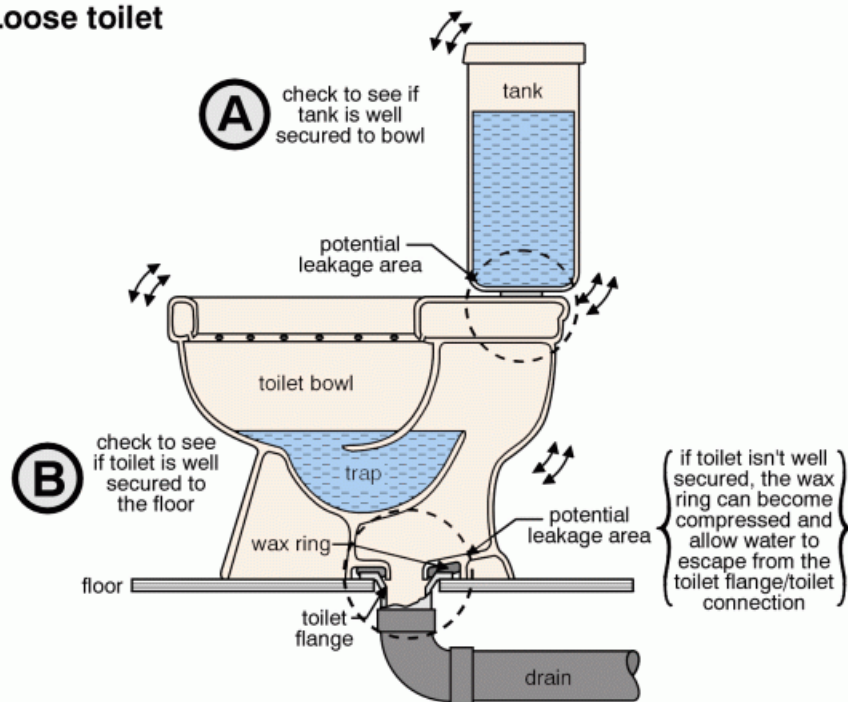
37. Condition: • [Loose](#)

Basement toilet is loose it should be removed inspected for damages to the wood structure and subfloor around it and reinstalled with a proper seal.

Implication(s): Chance of water damage to structure, finishes and contents | Sewage entering the building | Possible hidden damage

77. Loose

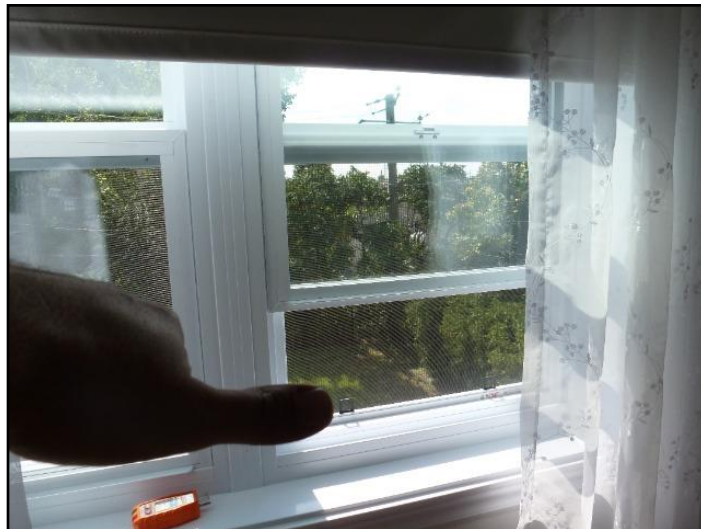
44. Condition: • Rear bedroom window is hard to open. Windows are recent and under warranty contact the manufacturer for corrections.

81. Hard to open

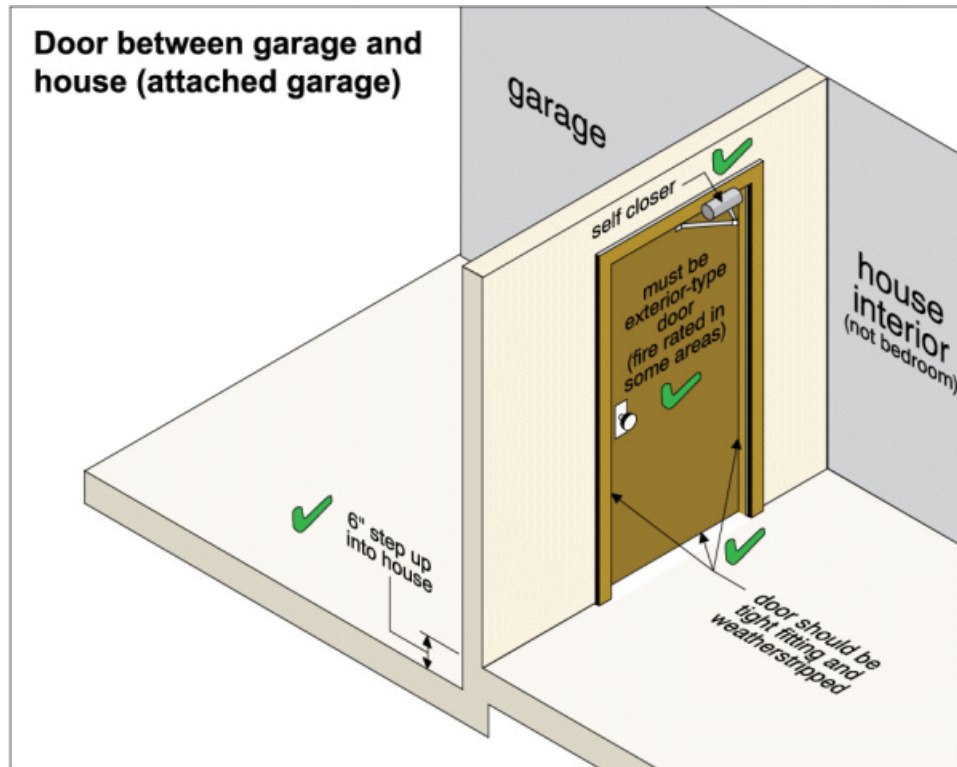
45. Condition: • [Inoperable](#)

82. Fire door doesn't shut

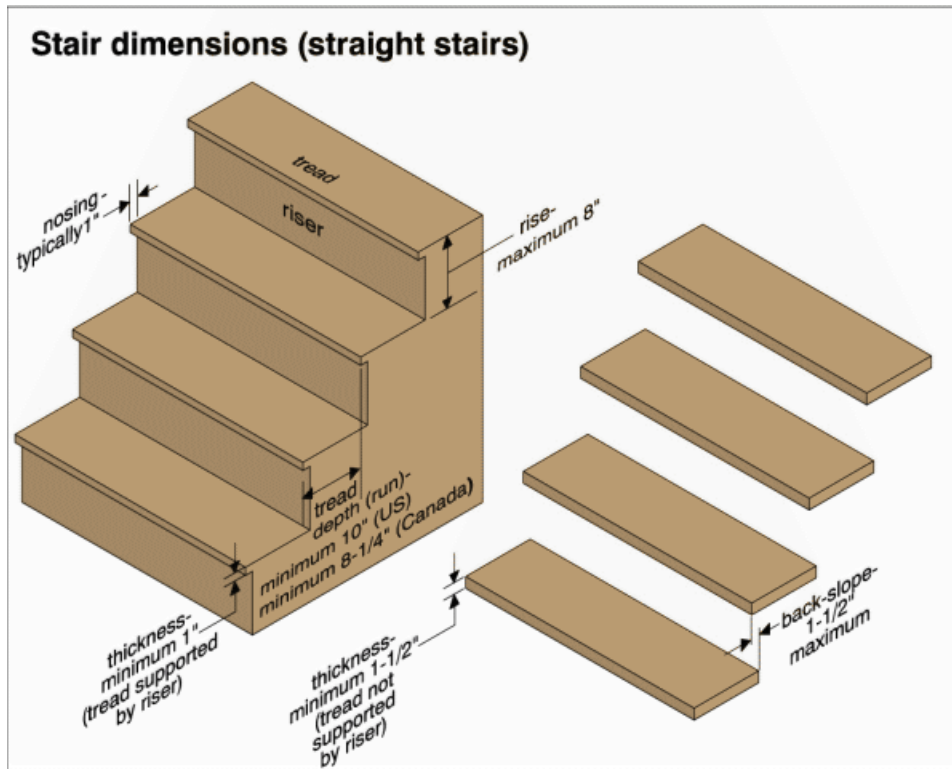
47. Condition: • [Rise or run not uniform](#)

Bottom step into the basement from the main home is of much lower height than the rest. This may cause a tripping hazard. Contact a certified general contractor for corrections.

Implication(s): Trip or fall hazard

84. Rise or run not uniform

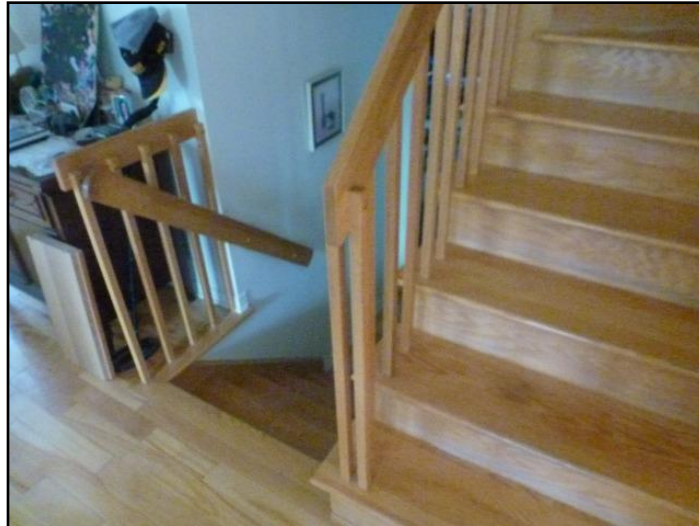
Implication(s): Trip fall hazard.

85. Handrail loose
